Subject: ArvinMeritor – Grenada Manufacturing Facility  
Grenada, Mississippi  
Additional Copy of the Corrective Measures Study Pre-Design Investigation Report

CORRECTIVE MEASURES PRE-DESIGN INVESTIGATION RESULTS  
FOR  
THE GRENADA MANUFACTURING FACILITY SITE  
GRENADA, MISSISSIPPI

February 21, 2008

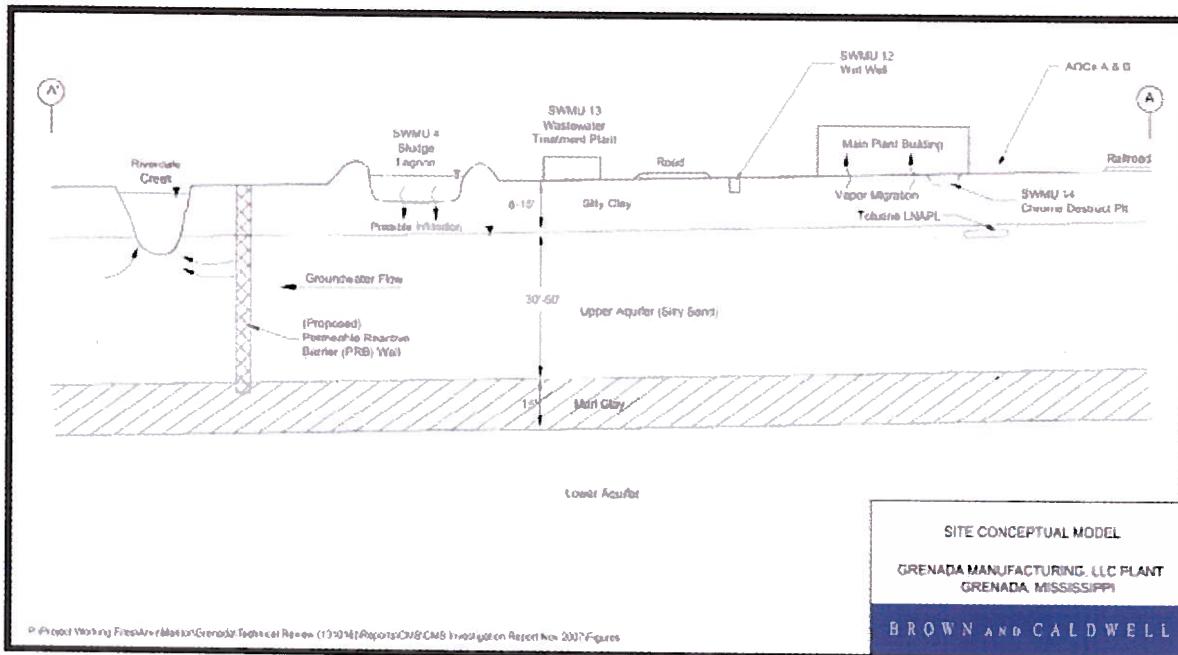
**Figure 1-3. Cross Section Illustrating the Site Conceptual Model**

Figure 1-3 shows a generalized cross section along the length of the Site parallel to the general direction of groundwater flow. The stratigraphy at the Site is comprised of approximately 8 to 15 feet of clayey silt or silty clay overlying approximately 30 to 50 feet of saturated, fine- to medium-grained sands that contain varying amounts of silt. Combined, these soils are referred to as the "upper aquifer." Within the vicinity of the Main Plant, the sand unit is bisected by a discontinuous clay unit at a depth between 20 and 30 feet. This clay unit was not observed in the western portion of the Site or in the vicinity of the PRB. At the base of the sand unit is a thinly-bedded, slightly-sandy, clayey silt, which is encountered at depths ranging from 47 to 60 feet below ground surface (bgs) and serves as an intermediate confining unit (ICU) that acts as an aquitard and separates the upper and lower aquifers. This layer is approximately 16 feet thick and has been identified as marl exhibiting much higher blow counts than the overlying soils. Below this unit is another sand layer that comprises the "lower aquifer."

The Upper Aquifer is the primary horizontal transport pathway for the Site. Groundwater in this aquifer is generally under semi-confined conditions, flows to the northwest, and discharges into Riverdale Creek. It is believed that Riverdale Creek is in direct communication with the Upper Aquifer. The Upper Aquifer is semi-confined above by the surficial confining unit and below by the lower clay unit. A significant upward gradient exists between the Upper and Lower Aquifers, thereby precluding the transport of constituents of concern to the Lower Aquifer from the Site. No impact has been identified in the lower aquifer.

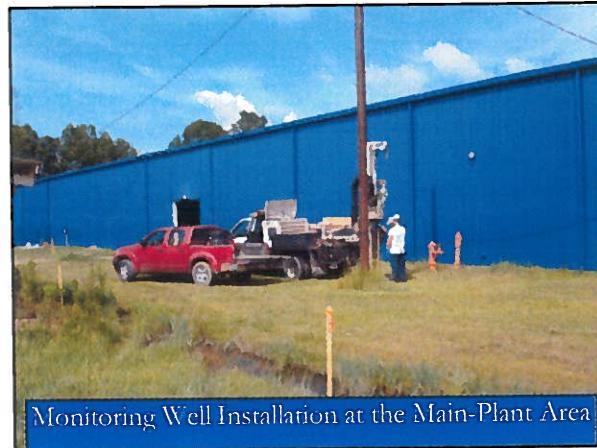
Temporary wells were installed using 4-foot lengths of 3.25-inch I.D. drill rods. An expendable stainless steel drill tip was used at each location. Once the rods were advanced to the appropriate depth, the well screens and casing sections were assembled and lowered into the drill rods. The temporary wells were constructed of 2-inch I.D., Schedule 40 PVC well casings and a 0.01-inch slot screen section. A threaded well cap was installed on the bottom of each well. The well materials were placed into the drill rods and held in place as the drill rods were pulled up from the ground, dislodging the expendable tip and leaving the bottom of the well at the target depth. For the temporary DNAPL detection wells, approximately 10 gallons of potable water was added to the well to add weight and assist in dislodging the expendable tip prior to pulling the drill rods. Once the drill rods were removed, the formation sands were allowed to collapse in around the screen and casing. Any portion of the annular space that did not collapse on its own was backfilled to above the top of the screen with clean sand, and then to ground surface with bentonite chips. For borings where no well materials were installed, the borehole was backfilled completely with bentonite chips.

Monitoring Well Installation at the Main-Plant Area

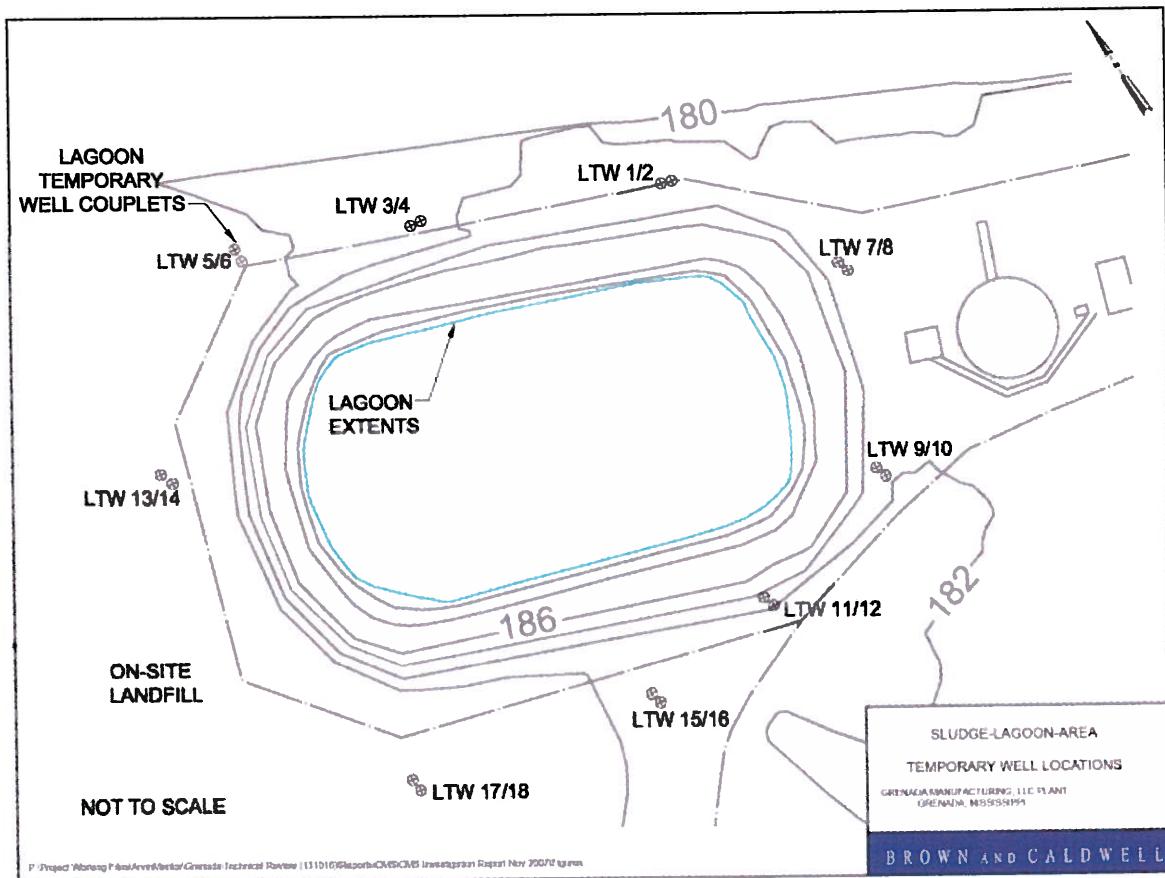
**Figure 2-2. Lagoon-Area Temporary Wells**

Nine temporary NAPL-detection well couples were installed around the perimeter of the Sludge Lagoon as shown in Figure 2-2. Inclement weather conditions in July made the ground very soft, and maneuvering the Geoprobe® rig was extremely difficult. As a result, nine well couples were installed in selected locations that provided adequate coverage around the lagoon to find and delineate the presence of NAPLs.

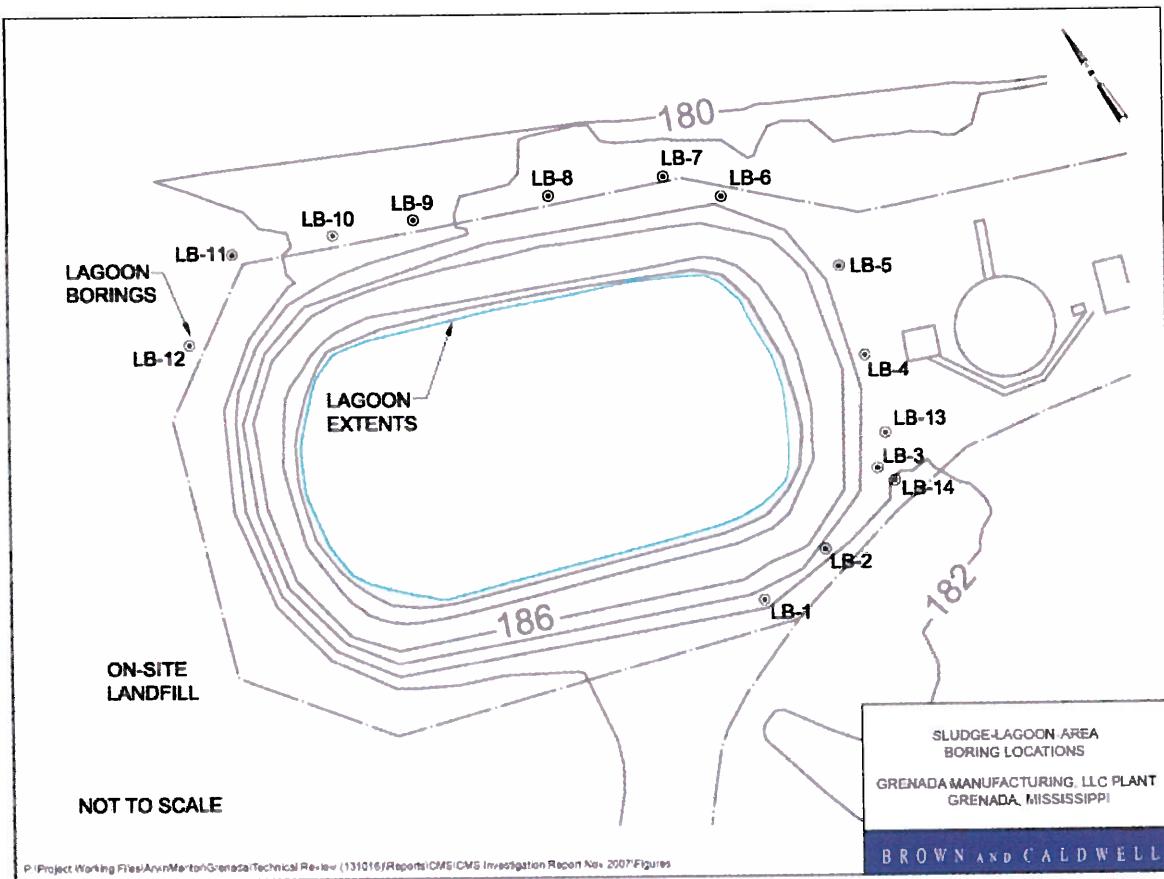
**Figure 3-1. Sludge-Lagoon Area Borings**

Contamination was detected in soils from one of the twelve locations identified as Lagoon Boring (LB)-3 located on the south east side of the lagoon (Table 3-1). A solvent odor was noted from the shallowest core at LB-3, and elevated headspace PID measurements were recorded in the cores retrieved from 4 to 12 feet bgs from that same location. To delineate the extent of contamination in this area, two additional “step-out” borings were advanced in the immediate vicinity of LB-3. Boring LB-13 was advanced approximately 20 feet to the northeast, and boring LB-14 was advanced approximately 15 feet to the southeast, of LB-3. Neither of these step-out borings showed evidence of contamination. Boring LB-12 also had a distinct organic odor and measured an elevated headspace PID reading of 406 parts per million (ppm). However, because LB-12 was located off the northwest corner of the Sludge Lagoon in an area where soil excavation and replacement had previously been completed as part of the former landfill remediation project, no additional step-out borings were completed in that area.

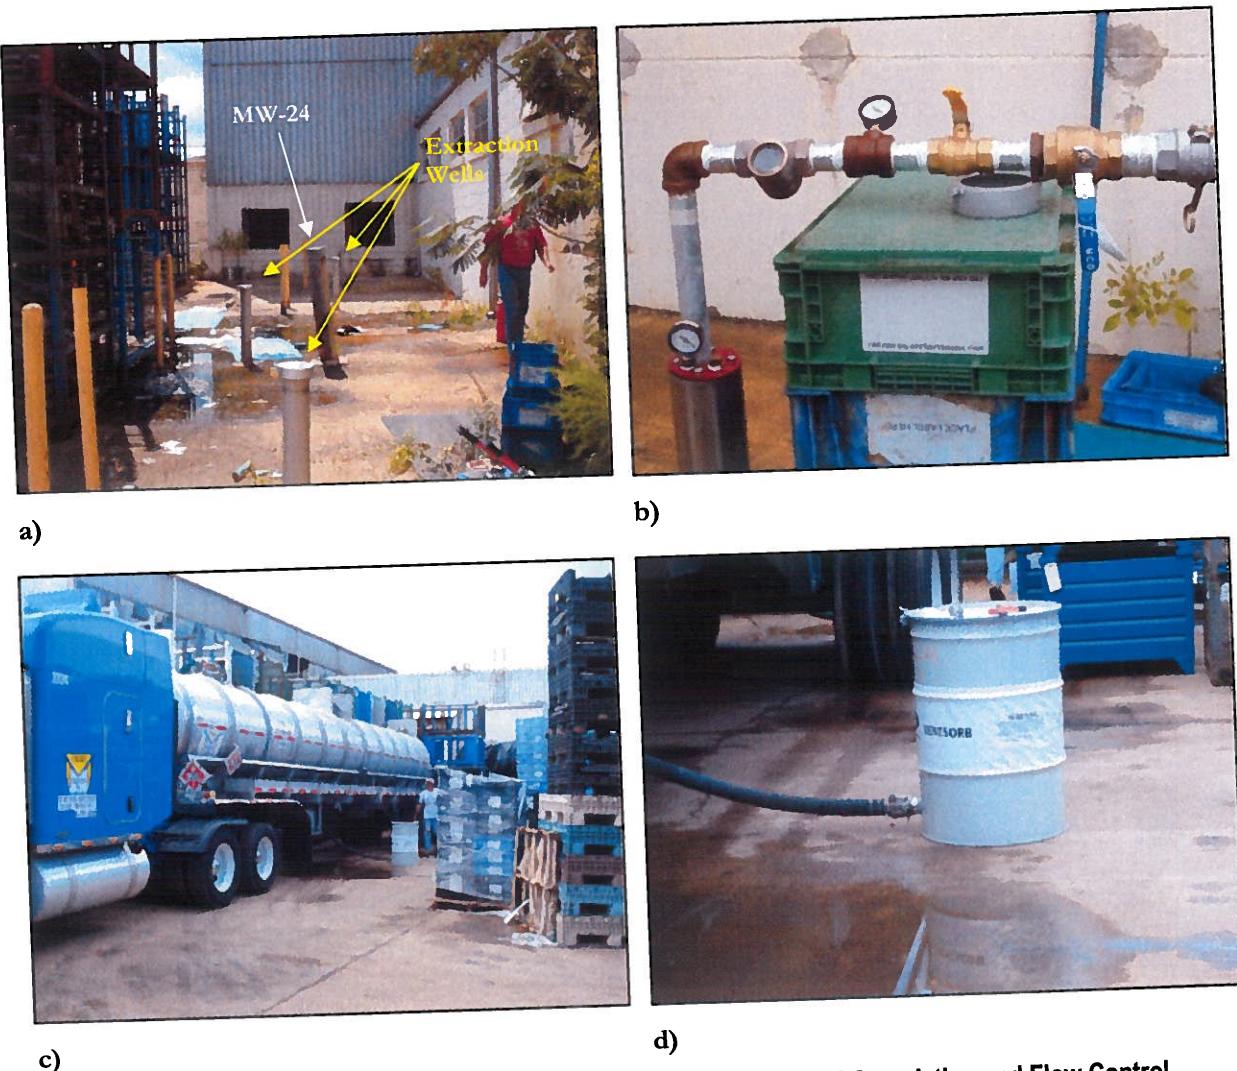
**Figure 6-2: HVMPE Setup:** a) Existing Extraction Wells; b) Well-head Completion and Flow Control Apparatus; c) Vacuum Truck; d) Off-gas Treatment Unit

A high-vacuum multi-phase-extraction (HVMPE) pilot test was conducted in October 2007. The test apparatus was sequentially connected to two existing extraction wells located in AOC B that contained measurable LNAPL at the time of the test. The high vacuum in the extraction apparatus imparted a much smaller vacuum on the well, and LNAPL recovery was largely limited to the material that was contained in the well casing at system startup. The vacuum caused the water table to rise at the extraction well, indicating a limited radius of influence and vapor/fluid flow. It was determined that the applied vacuum provided no enhancement to LNAPL recovery from the well. Accordingly, the technology was deemed inappropriate for LNAPL removal at this location. Additionally, sampling down gradient of AOC B has never shown toluene to be above the EPA MCL, indoor air monitoring at the Main Plant Building has never indicated the presence of volatile organic compounds (VOCs) at concentrations of concern, and the toluene appears to be contributing to some level of "natural attenuation" of the chlorinated solvents and metals, regulating their concentrations across the site (and in particular at the PRB). Based on the ineffectiveness of the HVMPE shown by the pilot test and the above mitigating factors, it is recommended that HVMPE not be pursued at the Site.
